Derailment Accident of an Automated Guideway Transit due to Great Earthquake

H. Ishida and K. Ogawa

**Japan Transport Safety Board
Tokyo, Japan**

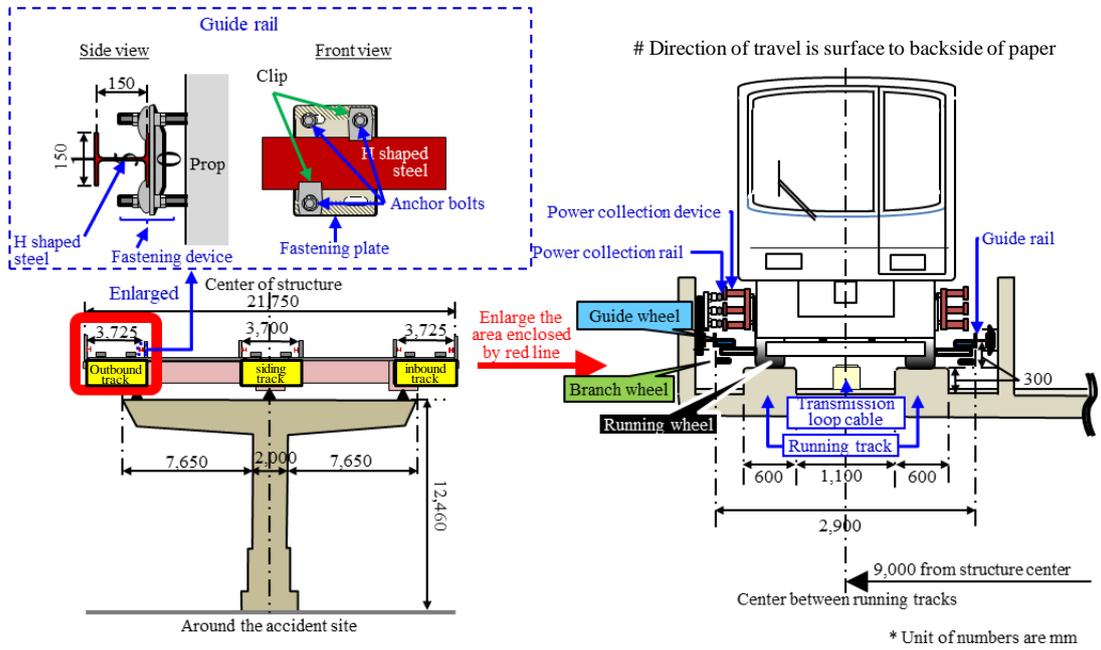
Figure 1: Outline of facilities around the accident site

The outline of the facilities in around the accident site is shown in Figure 1, and the guiding system of the train in the concerned turnout section is shown in Figure 2. The guide wheels contacting with the outer surface of the guide rail and the branch wheels contacting with the inner surface of the fixed guide plate installed only in the turnout are installed in each bogie of the vehicles. When the train entered the turnout from the straight direction, left side branch wheels of the vehicle were guided by inner side of the fixed guide plate on the side wall in the straight track side, as shown in Figure 2.

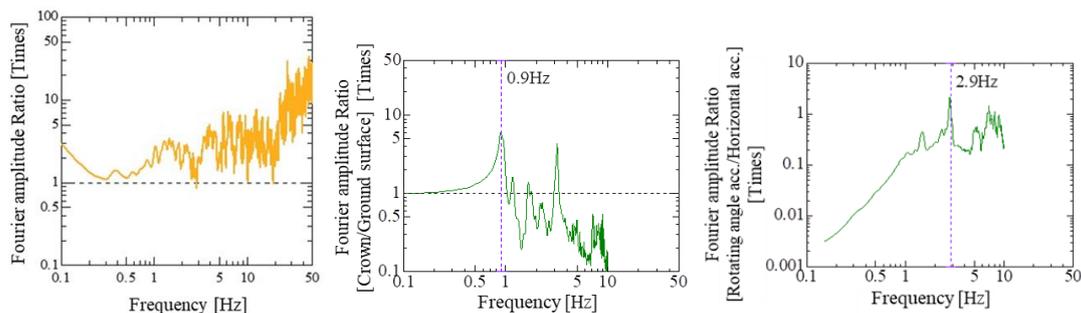
Figure 3: Earthquake amplifying characteristics of ground and structure

Figure 3 shows the calculation results of the earthquake amplifying characteristics between the ground surface at the derailment site and the observation spot (Figure 3 (a)) and the vibrating characteristics of the structure at the accident site (Figure 3 (b)). From the amplifying ratio, it was found that the seismic motion in the lateral direction around the accident site was larger than that at the observation spot in the Toneri Rolling Stock Depot. and that the lateral vibration on the top of the viaduct was larger than that on the ground at 0.9 Hz. Based on the Figure 3 (b-2), it was also found that there is the possibility that the viaduct around the accident site showed the rotating behavior in the rolling direction when earthquake occurred. It is likely that the ratio of the rotating behavior accompanied to the displacement in the lateral direction became to relatively large, because the viaduct around the accident site was the 3 tracks structure, which is the unique structure in the whole route, composed of the wide girder and supported by a long pier. The maximum values of acceleration were estimated to be about 354 gal in the lateral direction and about 440 gal in the vertical direction at the position where the train was running, *i.e.*, the position 9,000 mm apart from the center of the structure in the horizontal direction. On the other hand, the maximum vertical acceleration was 48.4 gal at the center position of the structure. Therefore, it is probable that the rolling motion of the viaduct amplified not only the lateral vibration but also the vertical vibration at the running track on the left side of the viaduct (Figure 1).

It is necessary to take measures that the guide wheel or the branch wheel of the vehicles do not run on the guide rail by the effects of the seismic vibration, in around the accident site where the natural frequency in the lateral direction of the viaduct and the natural frequency in the Rolling of the vehicle almost corresponded each other, and there is the possibility to be significantly affected by the rotating behavior of the structures due to the earthquake. In addition, it is expected to confirm the existence of the place having the possibility to cause the similar situation as the above, in the places other than the accident site, and take similar measures for the place required these measures.

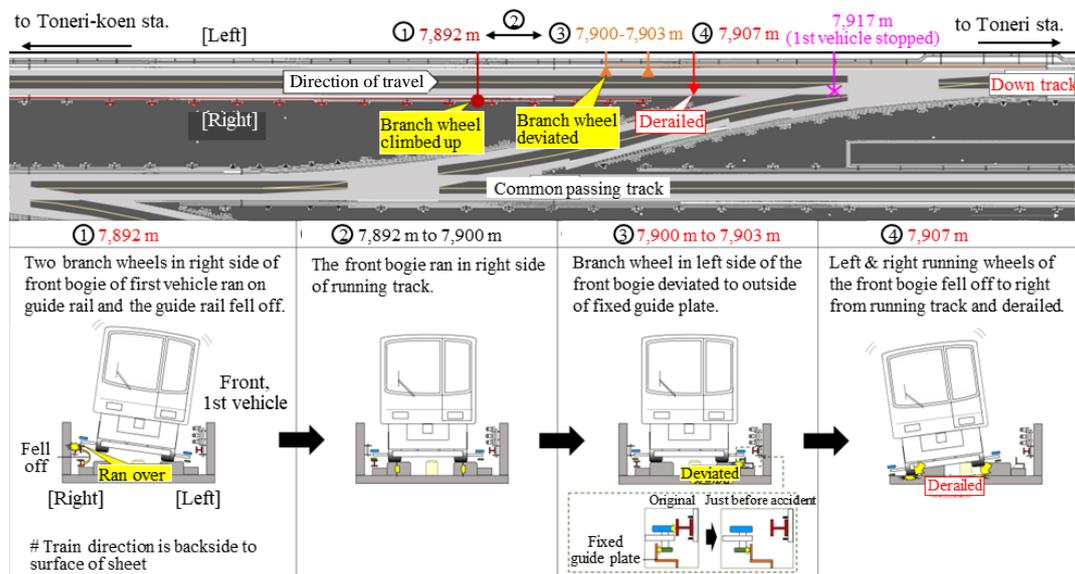
Figure 4. Process to derailment of the train

Based on the results of the vehicle behavior analysis, the both guide wheel and the branch wheel rose to the height exceeded the top of the guide rail when the rotating behavior of the structure in the earthquake was considered as well as the lateral seismic motion. In addition, considering the information on the damages and traces of the vehicles and the facilities around the accident site, the process to the derailment of the train was estimated as shown in Figure 4.

It is probable that the process to the derailment was as follows: The train shook hard in rolling direction by the seismic vibration, and right branch wheels in the front bogie of the first vehicle ran on the guide rail, and the guide rail fell off. It is probable that the bogie ran as being deflected to right side of the running track by the influence of the lost guide rail, and left branch wheel of the bogie deviated to outer side of the fixed guide plate installed in left side of the running track in ahead, and derailed.
