Proceedings of the Seventh International Conference on  
Railway Technology: Research, Development and Maintenance  
Edited by: J. Pombo

# **NTSB Investigations of Vertical Split Rim Failures of Freight Train Wheels**

**E. M. Mueller<sup>1</sup> and X. Liu<sup>2</sup>**

**<sup>1</sup>Office of Research and Engineering, National Transportation  
Safety Board (NTSB), Washington, DC, United States of  
America**

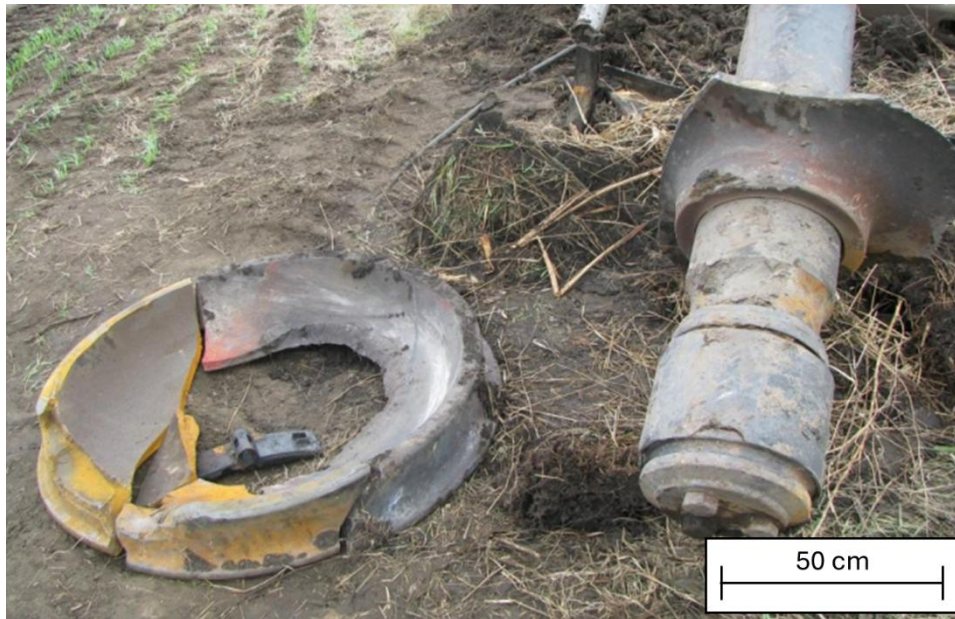
The fractured wheel fragments are shown in Figure 1, as found on-scene. This wheel exhibited four fractures towards the outer tread surface that were generally radial in orientation. There was also a slanted fracture closer to the axle location, oriented parallel to the circumferential direction of the wheel. This inner circumferential fracture mirrored that of the remnant still attached to one of the axle sections. Ultrasonic nondestructive inspection did not reveal any internal indications consistent with voids, inclusions, or discontinuities.

Figure 1: Fractured wheel remnants, photographed at the accident site.

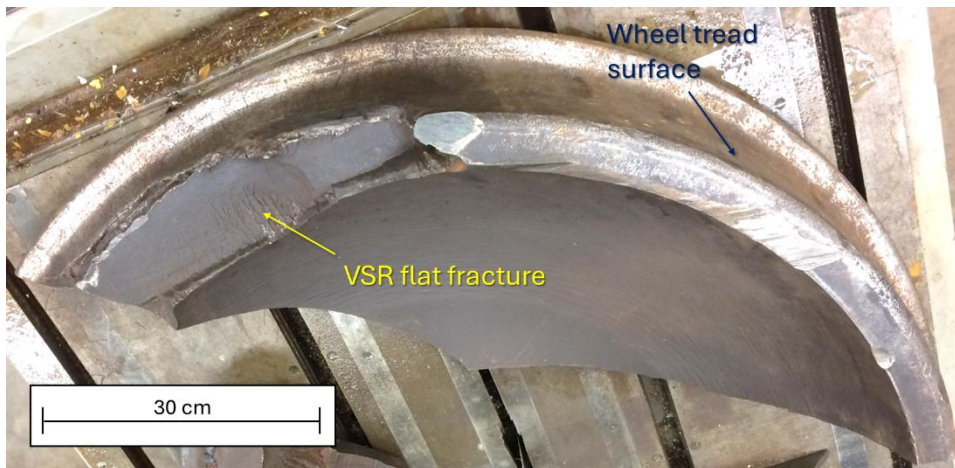
The second largest fragment of the fractured wheel exhibited a vertically oriented fracture surface on the outboard-facing rim of the wheel. This fracture is illustrated in Figure 2. This fracture exhibited three regions: an outer and an inner region, each oriented parallel to the running circumference of the train wheel, and a middle vertical region, oriented perpendicular to the wheel circumference.

Figure 2: Wheel fragment with the flat vertical fracture face, as received.

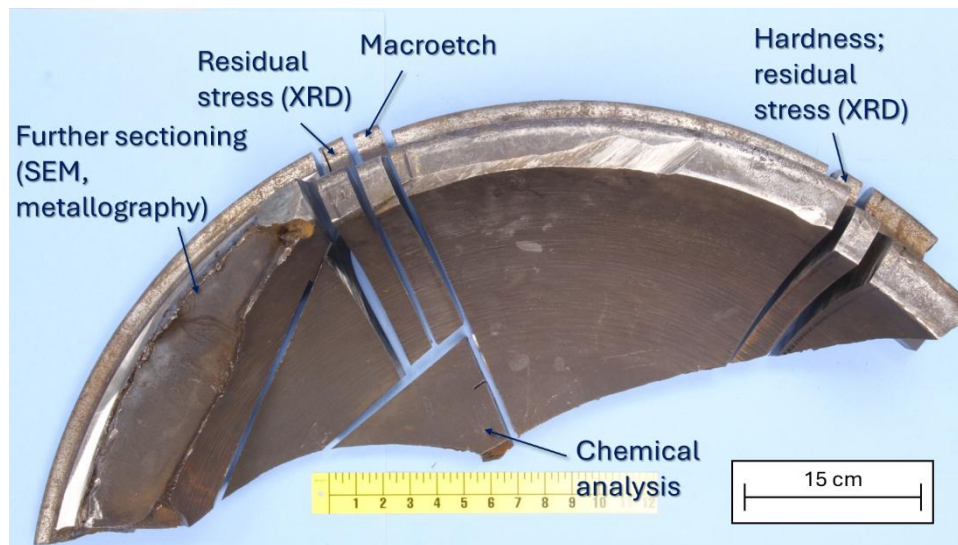
The fractured train wheel fragment with the vertical fracture face was sectioned repeatedly to produce specimens for additional testing and examination. Figure 3 shows the initial sections of this train wheel segment, the label given to each section in this study, and the purpose of several of the pieces.

Figure 3: Sections of the VSR wheel remnant and their respective testing purposes.

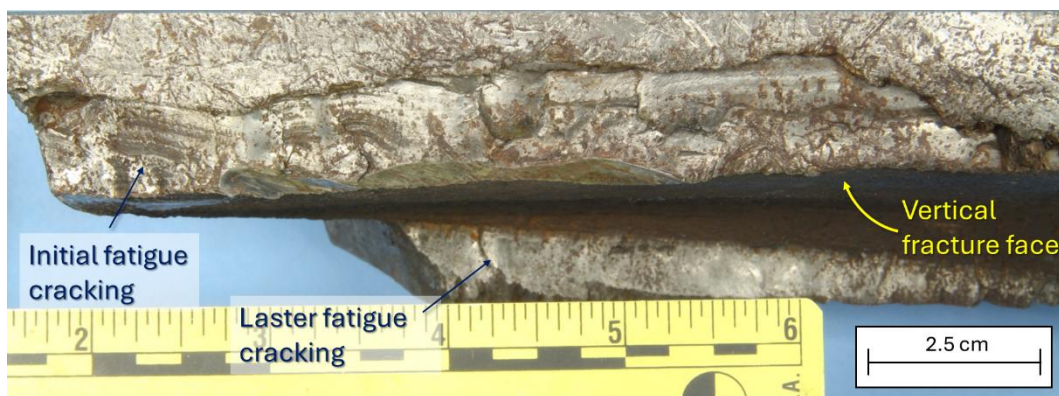
Figure 4 shows the tread surface of the wheel facing the reader, after cleaning. This tread surface exhibited heavy batter and deformation adjacent to the fracture, consistent with heavy impact forces and spalling of the tread surface and outer wheel. The initial fracture region displayed crack arrest marks, consistent with fatigue crack propagation, present approximately 33 mm below the wheel tread surface. These arrest marks were oriented parallel to the tread running surface, propagating from the rim to the inner flange of the wheel.

Figure 4: The subsurface (initial) progressive cracking viewed from the tread surface

Using digital calipers, these progressive cracks were approximately 15 mm in length from the vertical fracture face until they ran under the battered tread surface of the wheel. The presence of ratchet marks between the cracks was consistent with multiple cracks initiating separately and coalescing as they propagated. The vertical fracture face was oriented flat, exhibiting a rougher texture than the progressive fracture described above. The vertical fracture face exhibited river patterns consistent with the fracture growing from near the wheel tread toward the interior. No indications of progressive fracture were present on this section of the fracture surface.

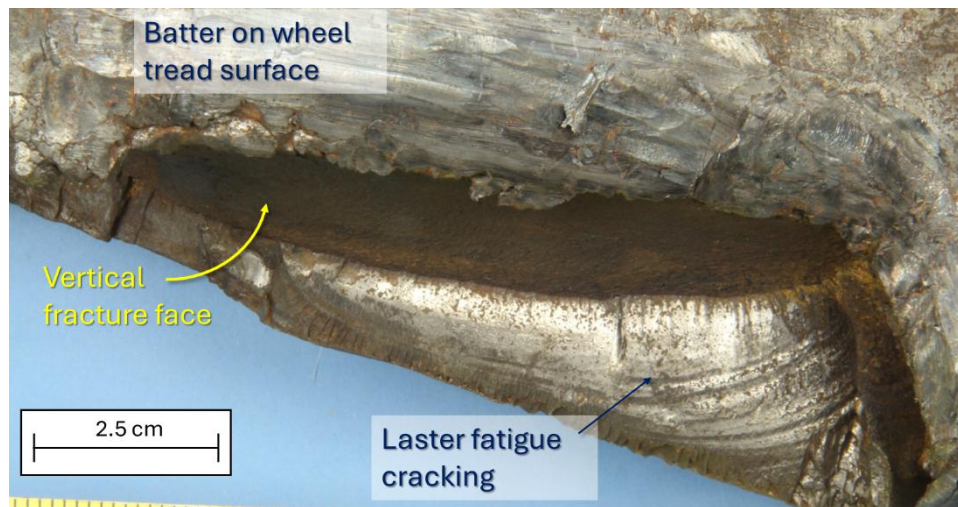
Figure 5 shows the inner set of visible crack arrest marks, consistent with fatigue propagation from the vertical fracture face towards the rim (field side) of the wheel. The largest portion of this progressive fracture extended approximately 38 mm away from the vertical fracture face.

Figure 5: Surface batter on the wheel tread surface, the vertical fracture face, and the inner perpendicular progressive fracture

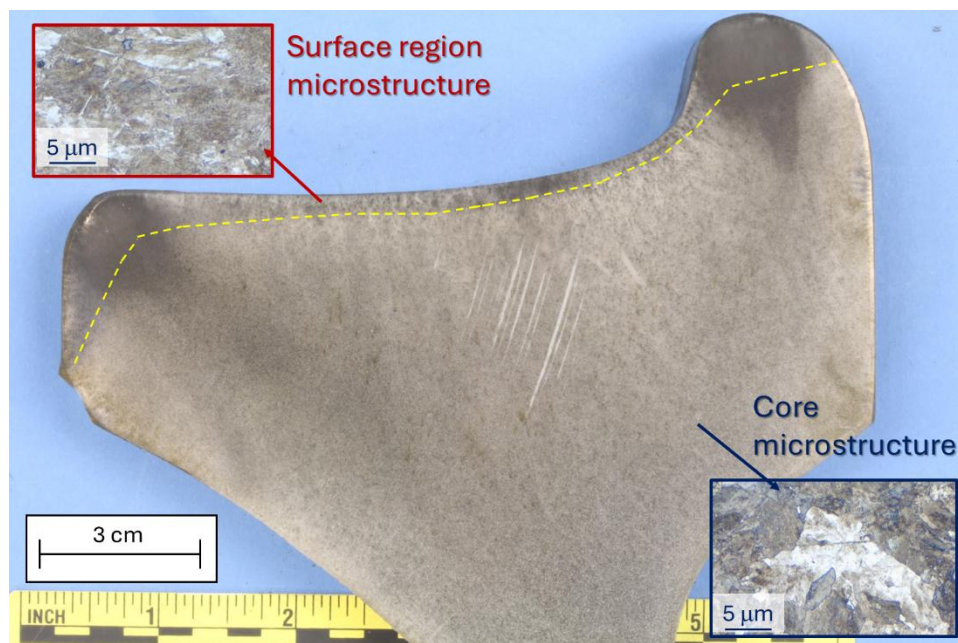
The macroetched section is shown in Figure 6. The wheel cross-section exhibited the dendritic structure typical of cast train wheels. No porosity or inclusions were noted on this sample. This etchant produced a darker contrast along the running surfaces, as annotated in the figure. Later optical metallographic examination showed a core microstructure of fine pearlite within the starburst morphology. The microstructure of the wheel closer to the surface also displayed a fine pearlite microstructure; however, the features were flattened and smaller, consistent with deformation present towards the wheel contact surface.

Figure 6: The macroetched cross section through intact wheel regions, showing different microstructure superimposed, and the area of surface distress annotated.

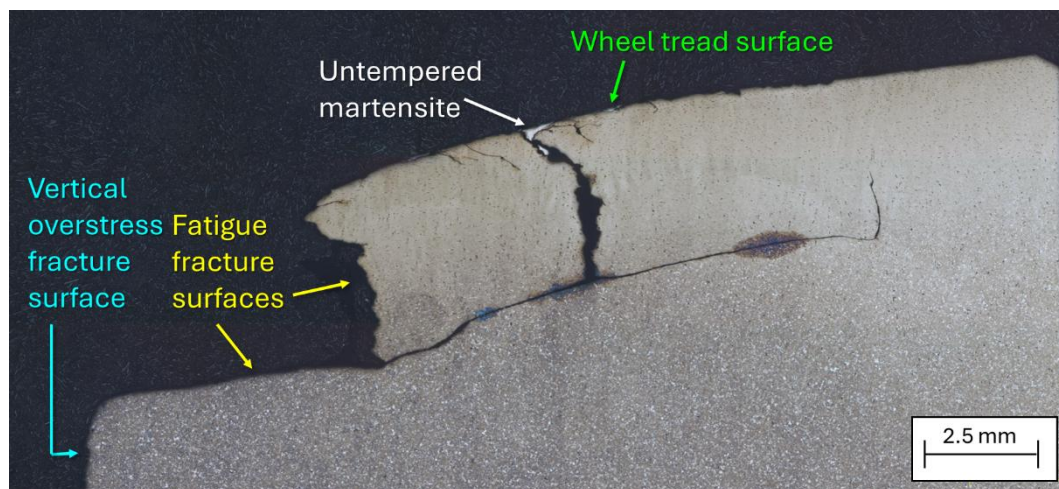
Figure 7 shows a montage of the tread surface cross-section. The fatigue fracture surfaces were oriented towards the left, with the top of the vertical overstress region in the lower left, with the tread surface facing upward. There was a large crack extending from the fatigue fracture parallel to the tread surface. This orientation and the features of this crack were consistent with the fatigue crack pictured in Figure 4 running from right to left. There was also an internal crack perpendicular to that crack, which extended towards the tread surface. At the terminus of the large crack parallel to the tread surface, the crack appeared to turn toward the wheel surface.

There were also cracks at the tread surface consistent with propagation from the outer surface inward (top of Figure 7). The surface material was white in color with no internal features, consistent with untempered martensite that formed when the steel was exposed to high temperatures and rapidly cooled as the heat dissipated into the bulk of the wheel [7]. Cracks were present between this surface phase and extended into the bulk of the wheel material.

Figure 7: Cross-section through the fracture surface, showing subsurface cracking, as well as the location of the fracture surface features.

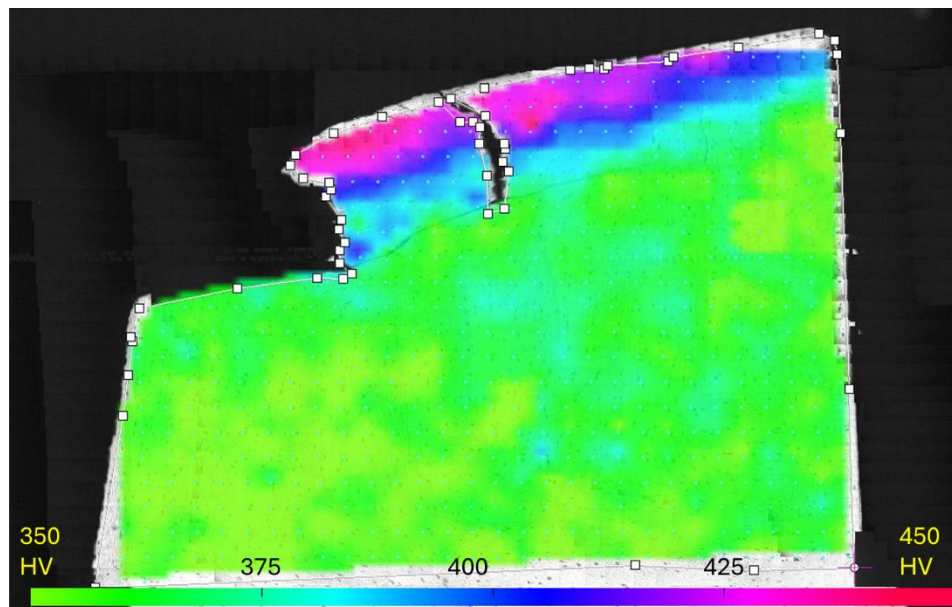
Figure 8 shows the data compiled as a false-color map, with hardness values organized from softest (yellow/green) to hardest (purple/red). The material closest to the train tread surface exhibited a higher hardness, up to 45 HRC (452 HV500), than the interior material, ~36 HRC (354 HV500). Along the crack (oriented horizontally), the difference in hardness was the highest between the outer and inner regions. This higher hardness near the tread surface was consistent with higher deformation and cold working present in the area.

Figure 8: – False colored hardness map of a wheel cross-section showing color from softest material (green) to hardest material (purple/red) in HV<sub>500</sub>.
