## **Accident investigation of an automated guideway transit running in reverse at a terminal station**

**<sup>1</sup>Japan Transport Safety Board  
Tokyo, Japan**

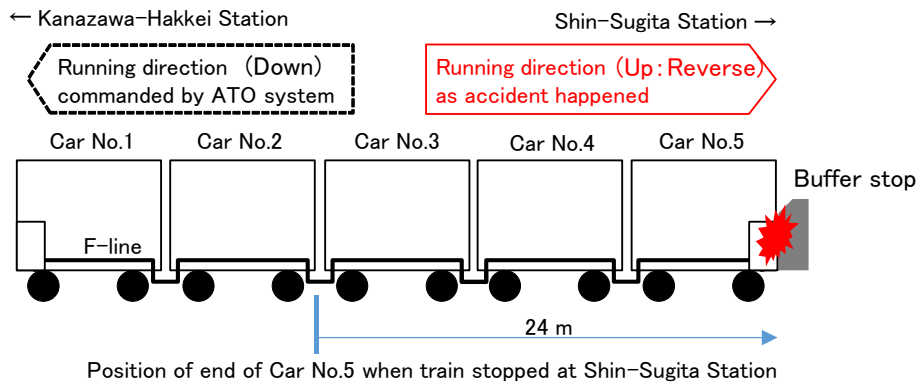
The accident occurred at Shin-Sugita station on the Seaside Line in Yokohama City (Japan) in June 2019. This line is an automated guideway transit (AGT), where the unmanned automatic train operation started in 1994 [7]. The 2009B train bound for Kanazawa-Hakkei Station, composed of 5 vehicles, started at Shin-Sugita terminal by turn. The train should have run in down direction according to the command from the wayside Automatic Train Operation (ATO) system, but it ran about 24 m in reverse, and crashed to the buffer stop at Shin-Sugita Station as shown in Figure 1.

Figure 1: Situation of the reverse run accident.

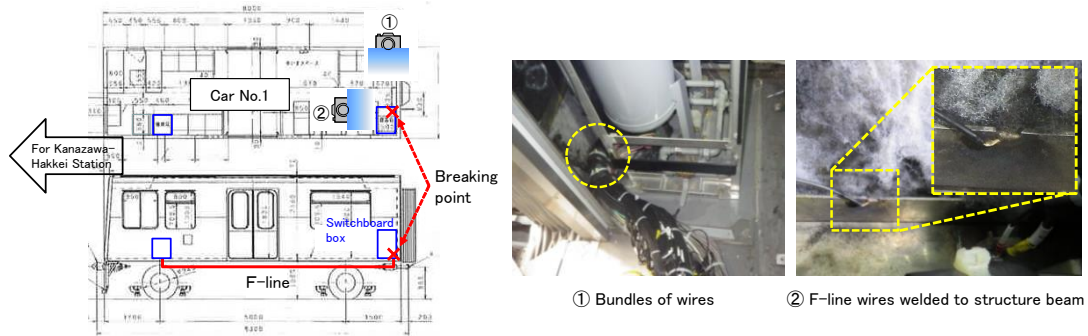
Through the continuity inspection of the circuit, it is found that a wire (F-line); which commands the down direction from an on-board ATO system to the motor control system; was broken in the first car (Car No.1) of the accident train that crashed to the buffer stop at Shin-Sugita station. Though the F-line and the R-line thread through the whole train set, from the result of the visual inspection, we found that the F-line broke at the rear area of Car No.1 and the one end of the wire was welded to the carbody structure beam made of the stainless steel (Figure 2).

Figure 2: F-line wire cut off with ground fault to stainless steel member of carbody.

The information that suggests any trouble related to the accident has not been found in other on-board and wayside control system. The cause of a ground fault of the wire has been investigated with the tests reproducing the contact condition of the wire to a stainless steel member, the vibration of the running vehicle and a voltage application. It is estimated that the insulating coating of the wire which was made of ethylene-tetrafluoroethylene was worn by the repeated application of the load of the cable bundle excited by the vehicle vibration to the contact point between the cable and the stainless member of the carbody.

With reference made to the JTSB's report 'Provision of Safety Information', the MLIT started the Council on Accident Prevention of Automated Guideway Transit with seven AGT operation companies in Japan. The council has been held three times so far, and determined to improve the software of the motor control system which caused the reverse running accident. The safety of the driverless ATO system including that operated by Yokohama Seaside Line has already been confirmed in the MLIT's Council [6]. The MLIT is now examining the improvement plan to solve the matters on the design system that were recommended by the JTSB.
