Proceedings of the Seventh International Conference on  
Railway Technology: Research, Development and Maintenance  
Edited by: J. Pombo

# **Experimental Investigation of Damage Morphology in High-Speed Railway Crossings with Different Structural Designs**

This study compares damage mechanisms in fixed and swing-nose crossings made of Hadfield manganese steel used in high-speed rail, with particular focus on the influence of impact loading on deformation behavior and crack morphology. Although Hadfield steel exhibits high work-hardening capacity, repeated wheel loading leads to progressive surface hardening and eventual fatigue crack initiation. Specimens extracted from in-service crossings were experimentally analyzed.

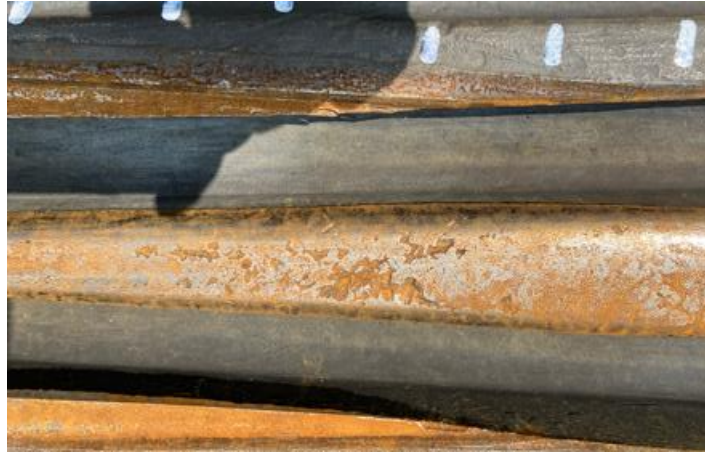
The fixed crossing was installed on a slab track with a JIS 60 kg rail, simple 1-in-14 turnout. The crossing experienced facing-direction traffic at a train speed of 80 km/h. Annual traffic tonnage was 48.5 million gross tons (MGT). Damage occurred after 13 months (cumulative 50 MGT), and the crossing was subsequently replaced. A photograph of the external condition is shown in Figure 1, showing surface spalling and cracking.

Figure 1: Defect appearing on fixed crossing.

Specimens were cut from the damaged noses for metallurgical investigation as indicated in Figures 1 and 2. Vickers hardness measurements (0.49 N load) were performed to determine the hardness distribution in the direction of depth. Optical microscopy was used to observe the etched microstructure. XRD analysis was carried out using  $\text{CuK}\alpha$  radiation in continuous scan mode over  $2\theta = 35\text{--}65^\circ$  with a step size of  $0.03^\circ$  and a counting time of 2 seconds per step.

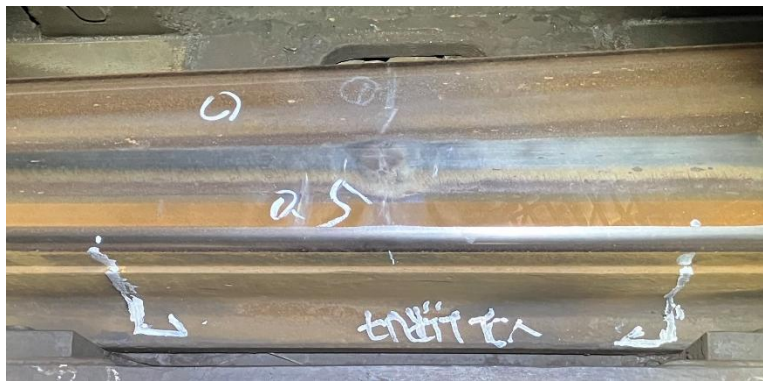
The swing-nose crossing was laid in ballast track with a JIS 60 kg rail, simple 1-in-16 turnout with annual traffic tonnage of 10.6 MGT. It was used for 18 years (cumulative 145 MGT) before being replaced due to surface damage. External condition is shown in Figure 2. A squat-like crack pattern was identified similar to that observed in rails.

Figure 2: Defect on swing-nose crossing.

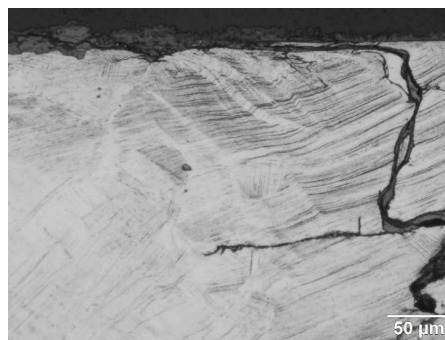
Figure 6 shows the rail longitudinal cross-section of the fixed crossing. Cracks propagated mainly parallel to the surface, with local surface spalling also observed. Vertical cracks extending into the material and internal horizontal cracks were also identified. Figure 7 shows a magnified view of the region marked in Figure 6. Deformation bands were densely distributed near cracks. Near the surface, the bands did not intersect but appeared bent with similar one-directional deformation bands reported in explosively hardened high-manganese steel [8]. Vertical loading may promote directional deformation, since slip in high-manganese steel occurs

preferentially along specific crystallographic directions. The bands observed are considered to be deformation twins and the apparent bending of the twins may be a result of material flow under high impact and shear during wheel transfer. Vertical crack propagation is attributed to impact stresses exceeding local fracture strength. Internal horizontal cracks may indicate that impact stress had been transmitted subsurfacely.

Figure 7: Observation results by optical microscope after etching.
