Proceedings of the Seventh International Conference on  
Railway Technology: Research, Development and Maintenance  
Edited by: J. Pombo

# **Towards Predictive Railway Infrastructure Monitoring Using Axle Box Acceleration: A Case Study of the Otta Bridge**

**C. Caspersen, M. Skjæveland, T. Ursin and A. Lau**

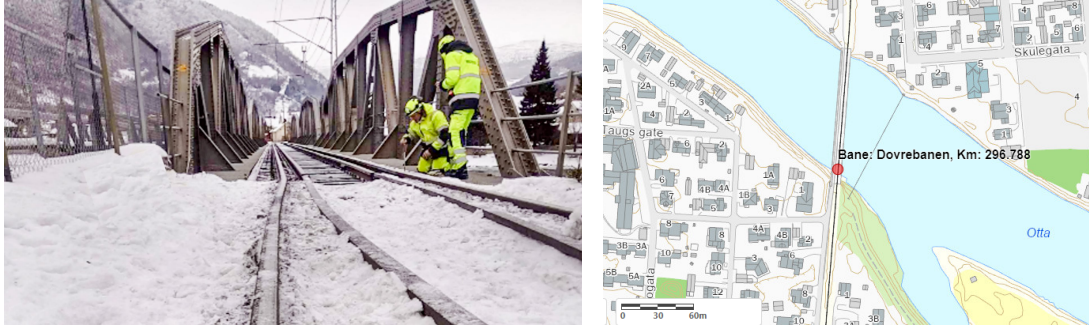
Figure 1: Railway bridge over the Otta river with visible track alignment and inspection work following the 2025 damage event [16] (left). Km 296.788 along the Dovre Line [4] (right).

In January 2025, train traffic on the Dovre Line in Norway was halted due to damage to the railway bridge over the Otta river, shown in Figure 1. High water levels and ice formation caused erosion around the southern abutment, leading to movement in the bridge foundation and displacement of the track shown in Figure 1 [15]. Such changes in the foundation and substructure can affect the dynamic response of both the bridge and adjacent track, for example through alterations in stiffness, damping, and load transfer. These effects may appear as changes in vibration levels and frequency content in acceleration measurements from passing trains, highlighting the need for more continuous and data driven monitoring of railway infrastructure.

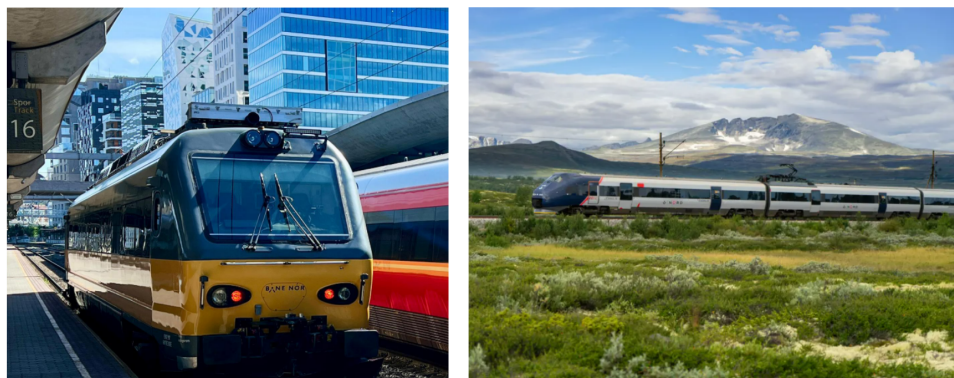
Figure 2: Picture of Roger 1000 (left) [5] and Type 73 train (right) [6].

Roger 1000 is a diesel powered railcar from 2001 equipped with two engines producing nearly 1000 horsepower. The train is 24 meters long and weighs 62 tonnes [12]. Approximately twice a year Roger 1000 measures track conditions including track geometry defects, lateral deviations, rail profiles, corrugation and wear in the rail surface, as well as acoustic measurements. Class 73A (Type 73) is an electric multiple unit consisting of four cars, three of which are powered. The trainsets were manufactured by ADtranz at Strømmen Værksted in Norway. Both trains are illustrated in Figure 2.
