Proceedings of the Eleventh International Conference on
Engineering Computational Technology
Edited by B.H.V. Topping and P. Iványi
Civil-Comp Conferences, Volume 2, Paper 12.1
Civil-Comp Press, Edinburgh, United Kingdom, 2022, doi: 10.4203/ccc.2.12.1
©Civil-Comp Ltd, Edinburgh, UK, 2022

Design and Implementation of Seismic Retrofitting of a Steel Bridge: Case study of Karim-Khan-Zand bridge in Tehran

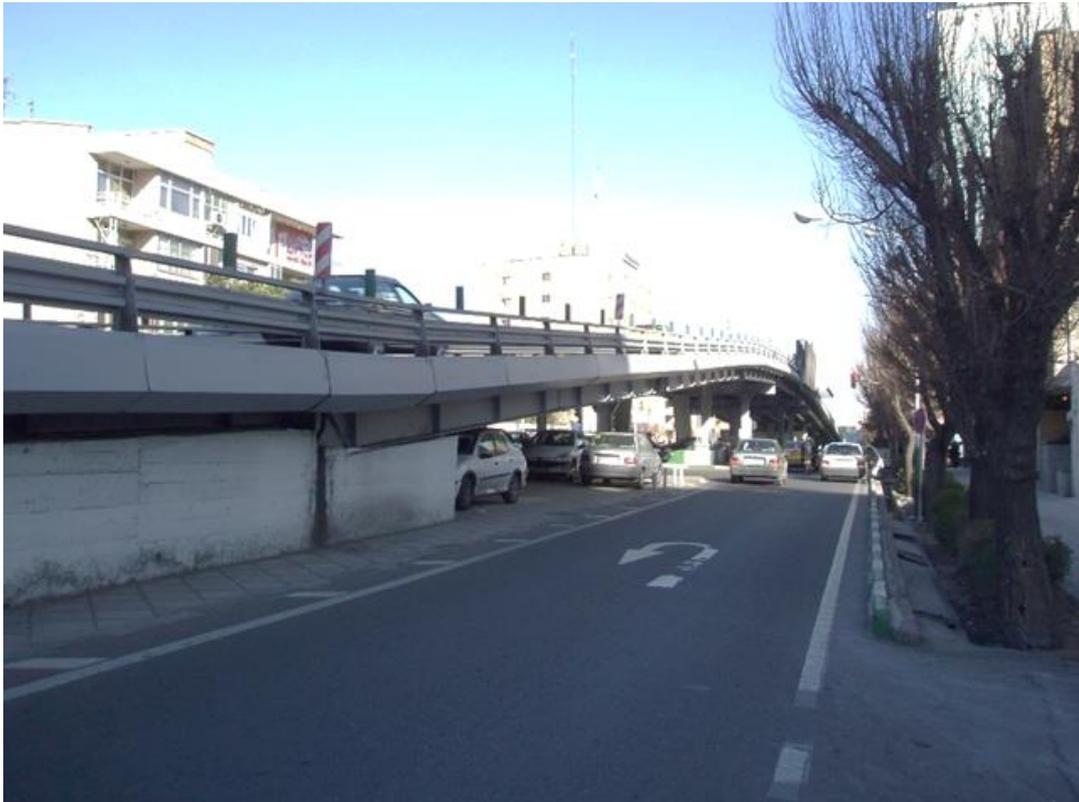
Figure 1: Karim-Khan-Zand bridge view.

Karim-Khan-Zand Bridge is located in District 6 of Tehran. This bridge is one of the temporary bridges in Tehran, which was built in 1973 by the Belgian company Nobel Spillman. The specifications of the structure are as follows:

- The bridge has 14 spans.
- Bridge columns are made of composite sections in the form of sheet beams. The middle column is with variable cross section and the side columns are fixed cross section.
- The bridge deck is made of steel and is orthotropic.
- Bridge foundations are of surface type.

- The total length of the bridge is 430 meters.
- The width of the bridge is 14.35 meters.
- The bridge has two round-trip routes and no sidewalk.
- The height of the columns varies from 0.70 meters to 5.75 meters.

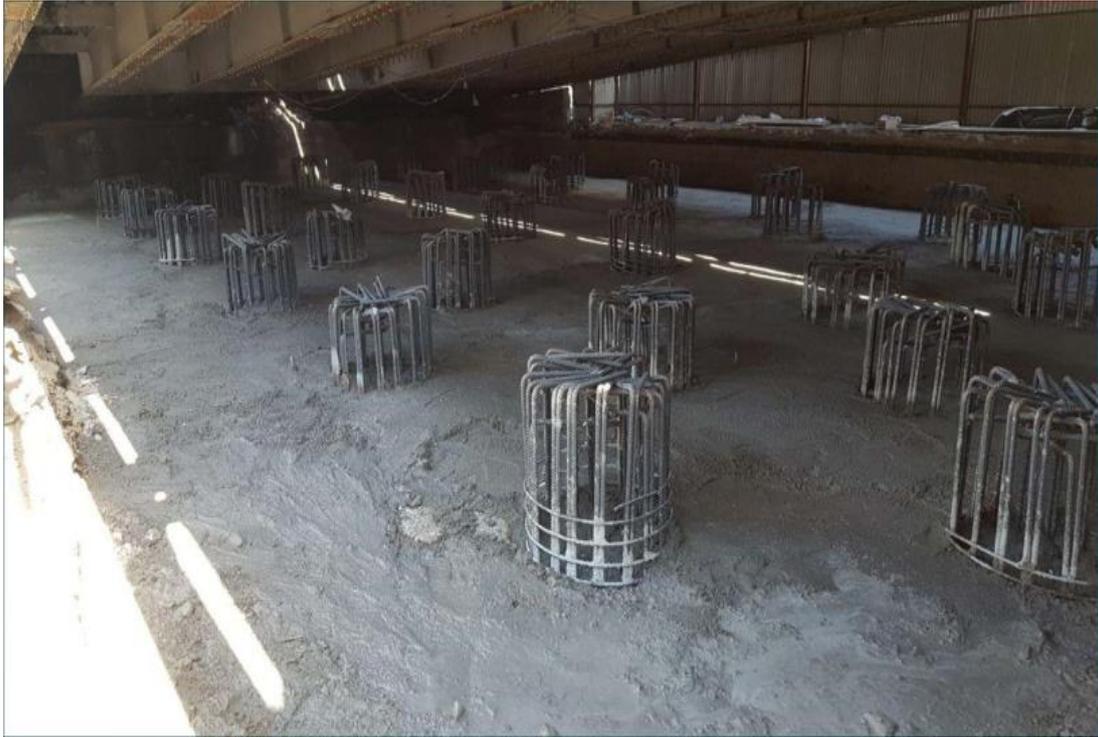
Figure 9: Piles concreting

- Execution of piles and foundations in two end zones of the bridge and connection to the bridge deck

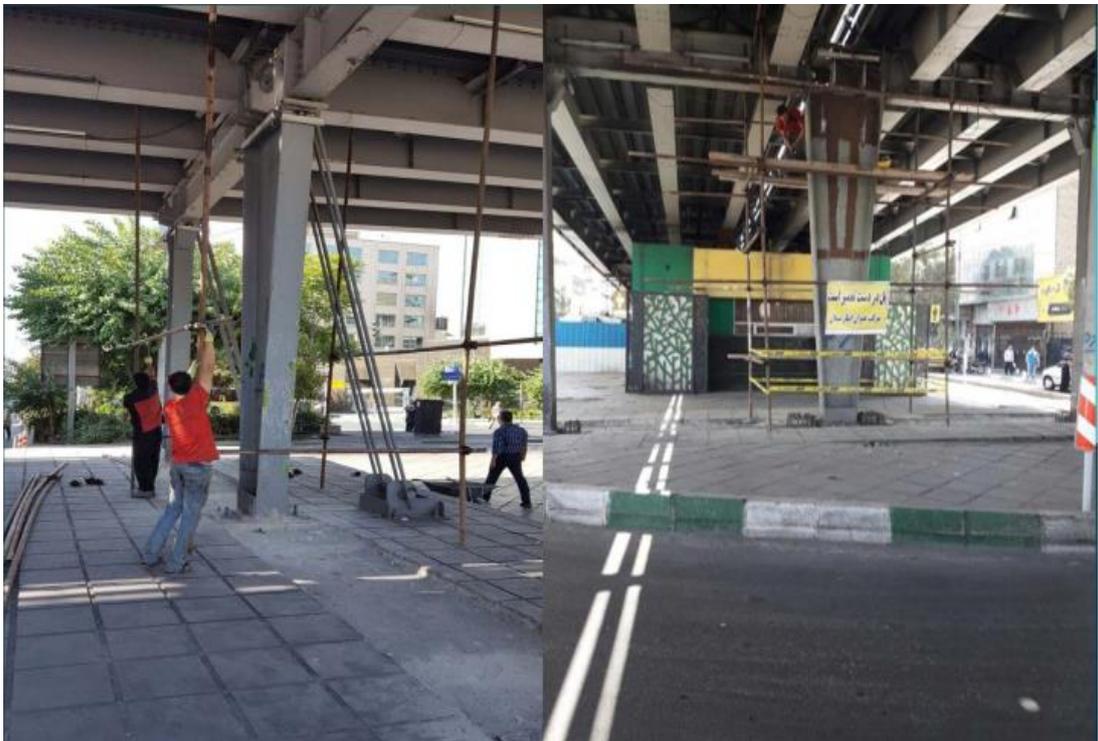
Figure 10: Scaffolding for the installation of reinforcement plates

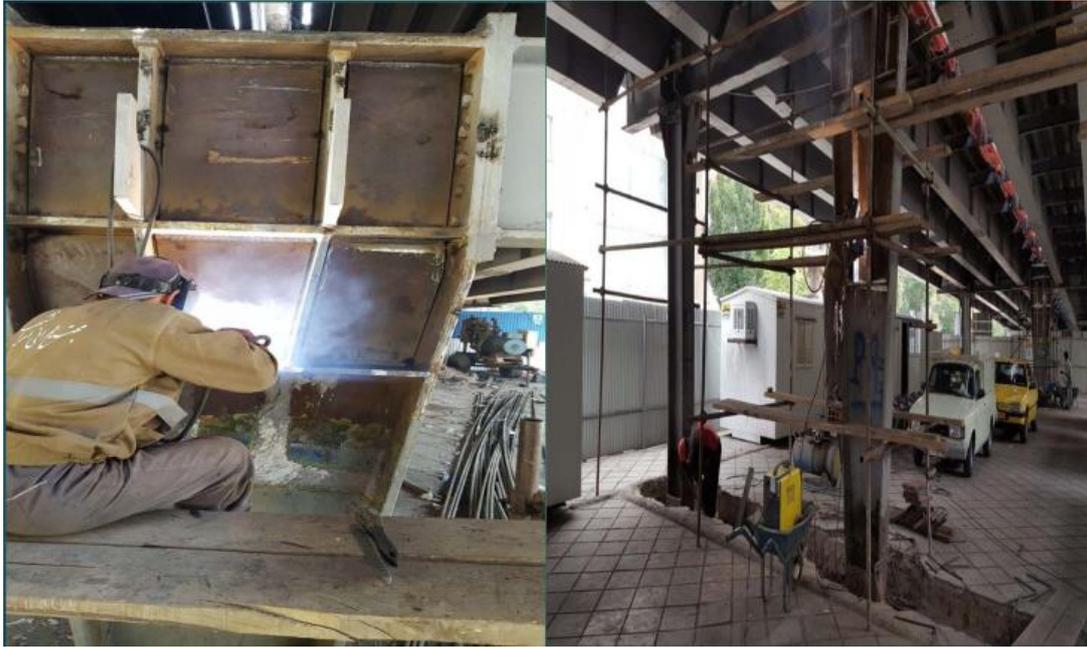
Figure 11: Installation of the reinforcement plates
