# **Initiatives for Dynamic Track Condition Monitoring on Local Railways Using In-Service Vehicles**

**H. Ono and N. Shinoda**

**National Traffic Safety and Environment Laboratory,  
Tokyo, Japan**

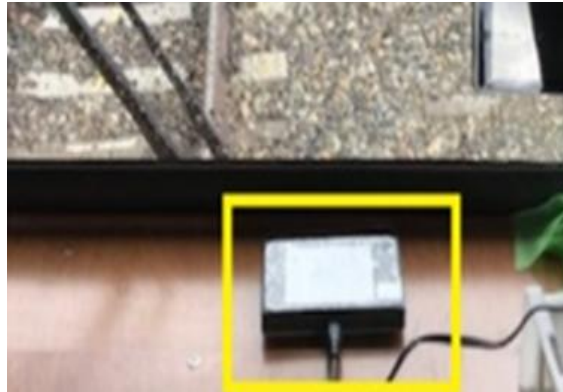
Compact devices equipped with accelerometers, gyroscopes, and GPS receivers are installed on in-service vehicles to measure vehicle vibration as shown in Figure 2.

Figure 2: Measurement of vehicle vibration by using a compact device.

The results of the field measurements conducted on an actual railway line indicate a clear correlation between vertical vehicle acceleration and longitudinal level irregularity.

Based on such a correlation, the degree of longitudinal level irregularity can be estimated solely from the measurement of vehicle vibration, even in the absence of recent track geometry data. For practical implementation, the vertical vibration acceleration threshold of  $2.1 \text{ m/s}^2$ , which corresponded to the vertical irregularity of 19 mm, was set as the maintenance target for a local railway. Since the correlation depends on vehicle type and operating conditions, threshold values must be determined individually.

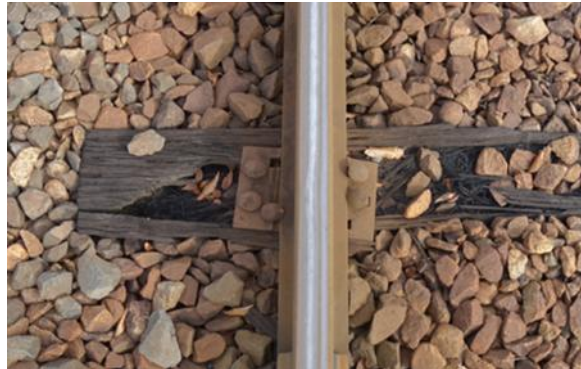
In sharp curves, large lateral forces are applied to the rails during train passage. As illustrated in Figure 7, when the fastening force continues to be reduced as a result of the sleeper deterioration over a certain distance, dynamic gauge widening may be caused.

Figure 7: Rotting of a wood sleeper [3].

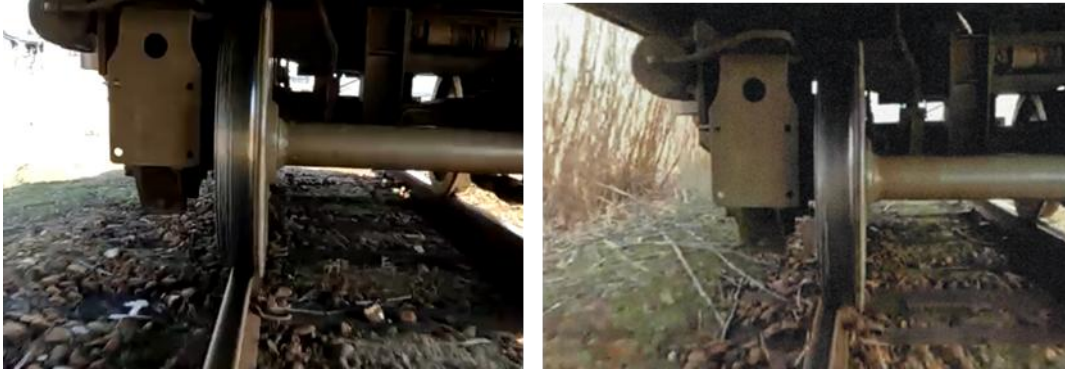
Figure 13 shows examples of images captured during mainline operations. The wheel and rail are clearly seen to provide sufficient image quality to assess their positions.

Figure 13: Examples of images captured during mainline operations.  
(Left : The whole area of the rail top surface is covered by the wheel  
Right : The partial area of the rail top surface is covered by the wheel)
