Proceedings of the Seventh International Conference on  
Railway Technology: Research, Development and Maintenance  
Edited by: J. Pombo

# **Rail Maintenance Solutions for Urban Networks**

**R. Stock, B. Antony and F. Aulinger**

**Plasser & Theurer, Austria**

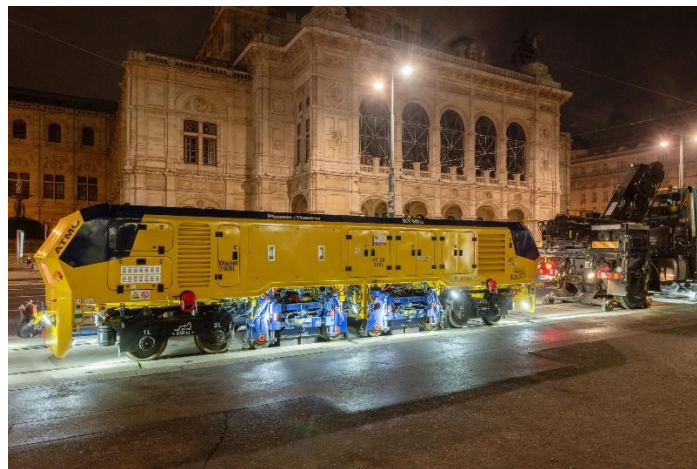
Figure 1: Urban rail grinding trailer ATMO (Automated Track Machine Oscillator) towed by a high-rail vehicle.

Out of several potential rail maintenance technologies block grinding technology was chosen as the most suitable technology [2]. Block grinding allows two operational modes. In oscillating mode, the blocks oscillate back and forth with a dedicated frequency and amplitude while the vehicle is moving. In sliding mode, the stones are dragged along the rail (without oscillation). The grinding blocks continuously adapt to the general shape of the railhead treating the running surface of the railhead (no gauge face or gauge corner treatment). This process creates a typical longitudinal profile but cannot adjust or create any transversal profile. With this operational flexibility it is possible to cover a wide range of speed requirements from 0 km/h (oscillation mode only) to more than 30 km/h (no minimum speed required). Although available since the 1970s, the block grinding technology had to be completely redesigned for its intended urban application. Due to space restrictions the grinding unit had to be re-developed from scratch including the oscillation drive system. These new grinding units were incorporated in a prototype compact maintenance trailer vehicle (ATMO – Automated Track Machine Oscillator, Figure 1). The ATMO has its own diesel power supply (in future versions: electric power supply) for the grinding units (to be independent of the towing vehicle) and a water tank (2600l) to create a thin water film on the rail surface to enhance grinding output. The vertical grinding stone force (3100-7080N for each grinding unit) as well as oscillation amplitude (55mm max.) and frequency (0-6Hz) can be varied within the provided parameters. A guidance system had to be designed for the grinding stones not to deviate from the ideal path in tight curves and to compensate for gauge variations due to rail wear. The trailer is equipped with two grinding units on each side. The trailer can be pushed or pulled by any suitable rail bound or high-rail vehicle. Due to its variable speed capabilities, the trailer can be used during revenue tramway operations (in between trains) or during non-operational hours, complying with requirements for preventive maintenance in the intended meaning [3].

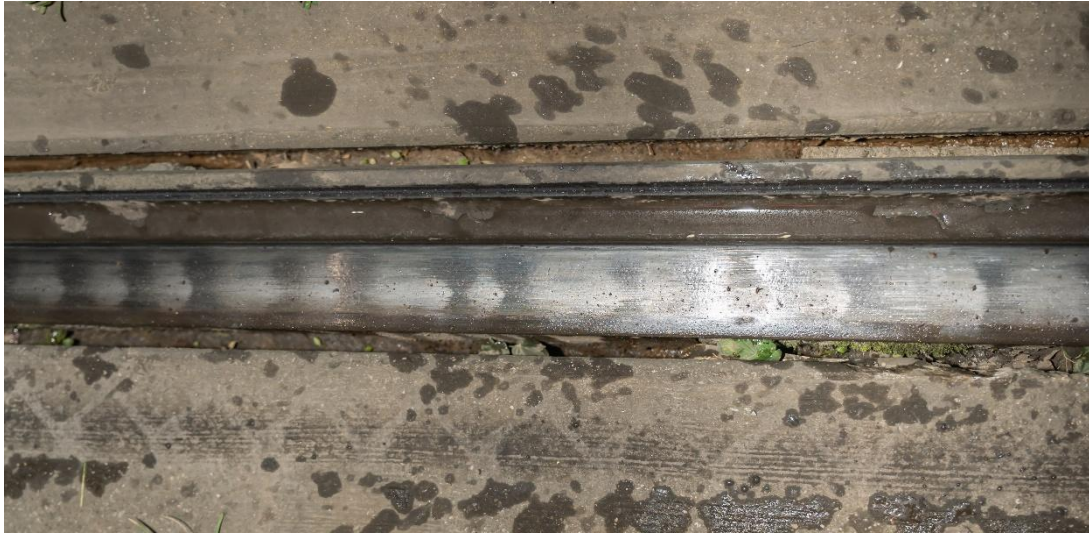
Figure 2: Example of corrugation severeness at selected track location

The next test program focused on surface irregularities removal in revenue tramway track of Wiener Linien. A tangent track location on “Simmeringer Hauptstrasse” close to Vienna Central Cemetery that was known to consistently develop corrugation (Figure 2) [4] was selected for this purpose.

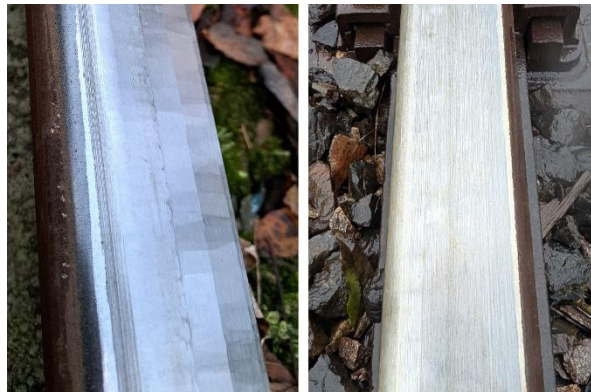
Figure 10: Left - rail surface condition directly after milling (milling grooves visible) with no post processing. Right - rail surface condition after one ATMO pass.

The surface structure directly after rail milling (honeycomb like milling grooves – see Figure 10 left) can cause unwanted tonal noise effects [9]. Although this structure will eventually wear out it might stay on the rail surface for several days or weeks dependent on the local traffic condition. To prevent this unwanted noise effect from happening, polishing systems are integrated into milling machines that flatten out this structure on TOR – see Figure 10 right.
