Proceedings of the Fifth International Conference on
Railway Technology:
Research, Development and Maintenance
Edited by J. Pombo
Civil-Comp Conferences, Volume 1, Paper 16.1
Civil-Comp Press, Edinburgh, United Kingdom, 2022, doi: 10.4203/ccc.1.16.1
©Civil-Comp Ltd, Edinburgh, UK, 2022

Thermal Imaging of Wheel-Rail Interface as a Tool for Multipoint Contact Detection

Institute of Transport, Poznan University of Technology, Poland

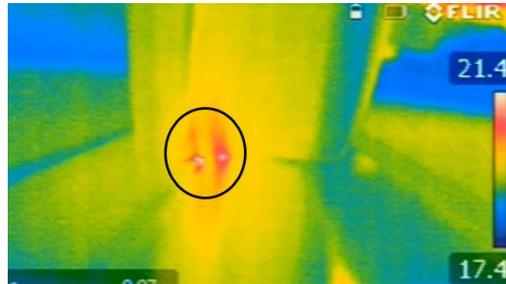
Figure 3: Thermogram of a multipoint contact between wheel and rail during curve negotiation.

Two-point contact was most often observed when the investigated wheel was an inner wheel in a curve. The additional contact occurred between the wheel flange and the rail (Figure 3).
